PPMS Service Note 1070-206

Overheating of the Red Lemo Magnet Connector Cable

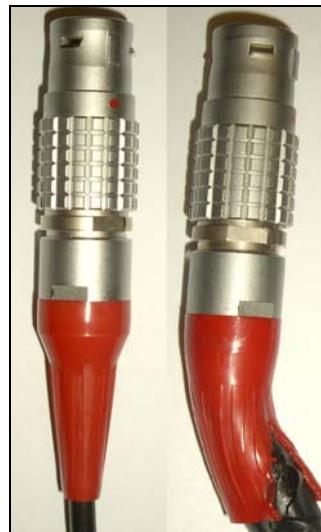
In early designs of the Red Lemo magnet connector cable, between the magnet controller and the probe head, there has been evidence of overheating in the lemo end of the cable during extensive magnet charging. The heating of the cable can cause it to melt and short the positive and negative lines. This short will then lead to magnet charging problems. Therefore it is crucial to check for signs of overheating in order to maintain proper magnet operation.

If your system has a REV A or B cable, check the cable for overheating. To check for overheating of the Red Lemo cable, ensure the red boot of the lemo connector shows no sign of discoloration or melting due to heat. Figure 2 shows an example of a good lemo connector and a bad one after overheating.

Figure 2. Comparison of Red Lemo cable before (left) and after (right) overheating.

If your system has the older style cable (REV A or B) and you suspect your cable is showing signs of overheating, contact Customer Service at Quantum Design to have a new replacement cable sent to you at no cost. If there is no evidence of overheating, continue normal magnet operation and periodically check the Red Lemo connector.
